IMPROVED WINDSHIELD AND CANOPY PROTECTION
DEVELOPMENT PROGRAM

H. EDWARD LITTELL, JR.
PPG INDUSTRIES, INC.
PITTSBURGH, PA. 15238

TECHNICAL REPORT
AFFDL-TR-74-75

JUNE 1974

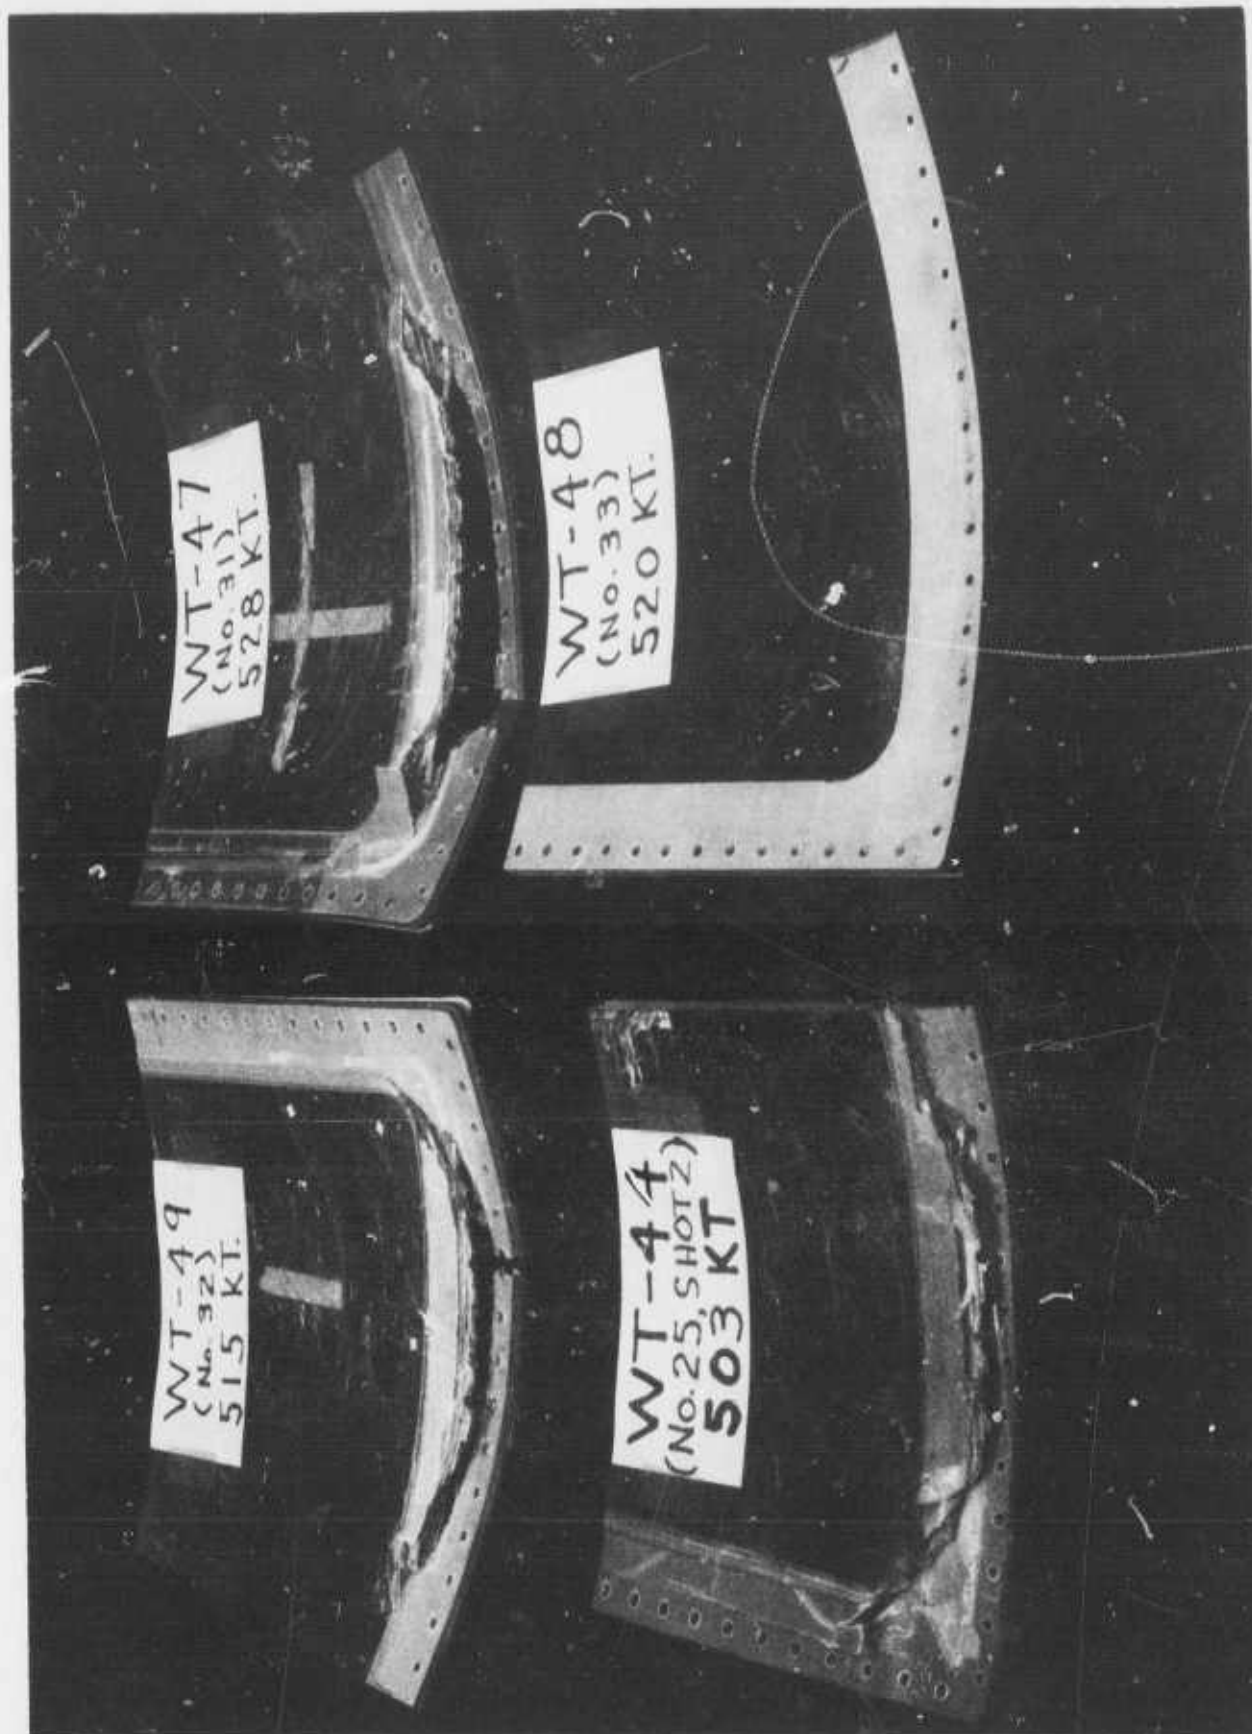
FIGURE 44. AFT BEAM WINDSHIELD SECTIONS; NOMINAL 500 KT. IMPACTS IN F-111 MODULE

As shown in Figure 44, there were improvements over WT-44 in the performance of windshields with two extended PC structural plies (tests WT-47 and -49), even at higher impact energy. But, the changes since WT-44 were insufficient to prevent penetration. Fracture analyses of sections of the two windshields tested with support strips and rounded ends on the arch mounting flange revealed that the catastrophic shearing of the inboard PC ply which occurred in WT-44 had been eliminated. In WT-47, the fracture of the inboard PC ply began from numerous origins on both surfaces. In WT-49, the origins in the inboard PC were from the outboard (tension) surface. In both cases, the failures of the inboard PC were still coincident with the end of the arch flange. The outboard extended PC ply of both windshields failed in tension from origins near the bolt holes. Overall, however, there was only slight difference between WT-47 and -49 insofar as the extent of impact damage experienced.

A windshield with a third extended ply of .125" PC survived a 520 knot impact in the aft beam corner in WT-48. The impact resulted in no serious structural damage to the transparency (see Figure 44) or reinforced arch. Therefore, a windshield/arch combination existed which met the bird impact requirement in the worst location. At 61.3 lbs, this design was within the contract weight requirement but other difficulties, such as interfacing with mold line, low light transmittance, and an exposed inboard PC ply, indicated a need for optimization.

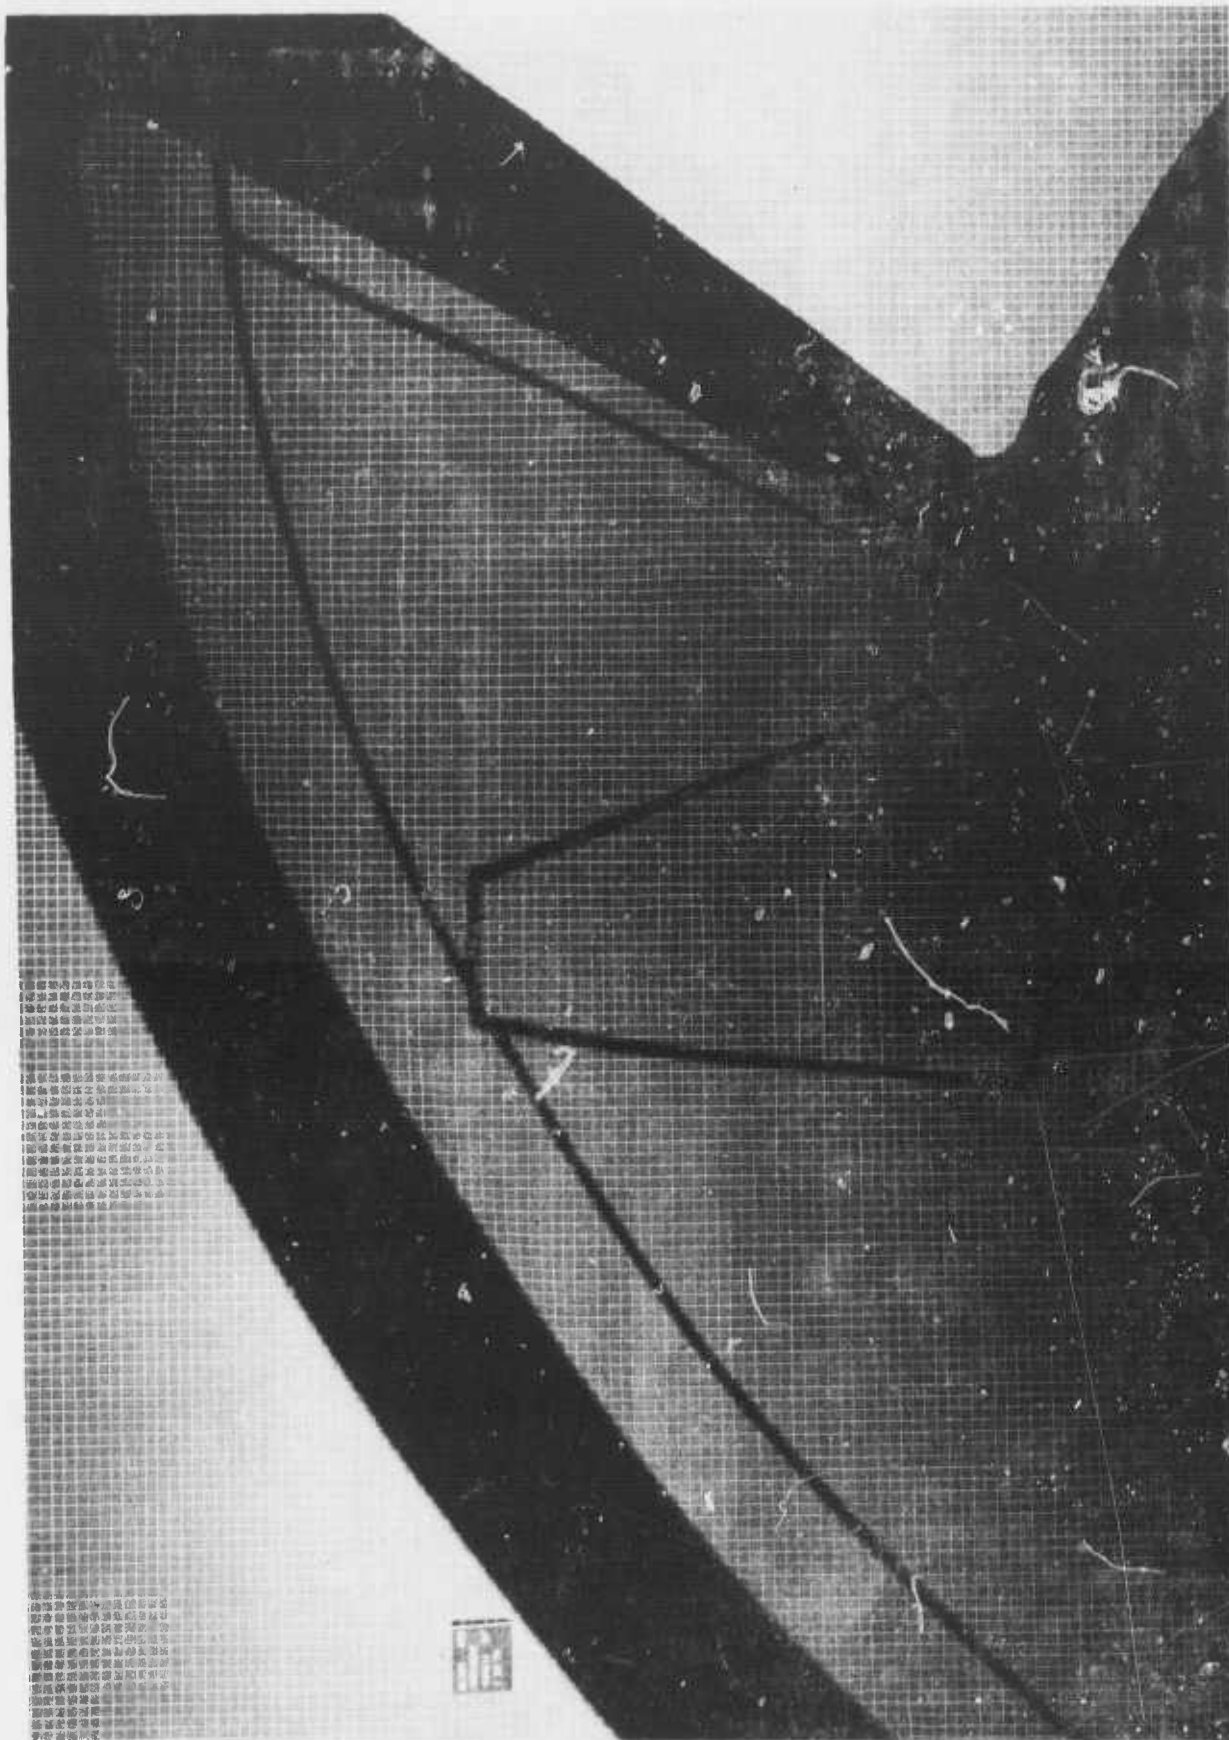
FIGURE 51. TASK III L/H WINDSHIELD (401611 RF) GRIDBOARD PHOTO

These windshields did not meet the subjective interpretation of Section 5.2, Visual Optical, which relates to immediately apparent bending, blurring, divergency, convergency or jumping of grid lines. The number of specific exceptions per panel has been included in the "comments" columns of Tables XIX and XX. They range from 2 to 9 cases with the R/H panels generally better than L/H parts, due primarily to the relative quality of laminating tooling. Figures 51 and 52 show gridboard photos of two windshields which demonstrate both the type of optical defects and generally distortion-free center panel areas encountered in the prototype windshield development. Figure 51 shows a left-hand windshield (401611 RF) which meets the ATP requirements for Mark I and Mark II deviation plus lensing and displacement. Items which fall outside Section 5.2 for this windshield are the forward arch bands which encroach on the critical area and a bull's-eye located in the forward beam-side portion of the critical area. In Figure 52, fewer and less severe distortion bands are present in the forward critical area of this right-hand windshield (401612 RF). However, this optical delivery part, which again meets the ATP deviation, lensing and displacement requirements, does exhibit aft arch roll-off present on most of the prototype windshields.

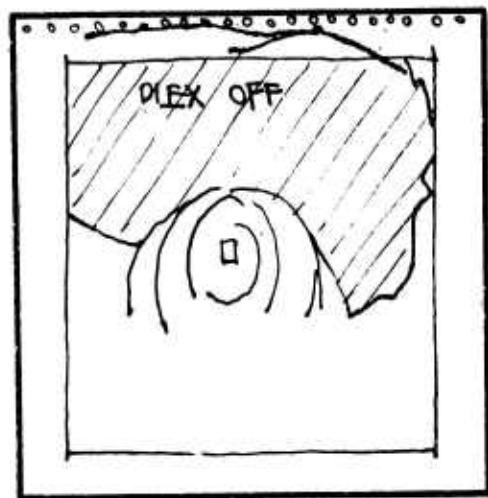
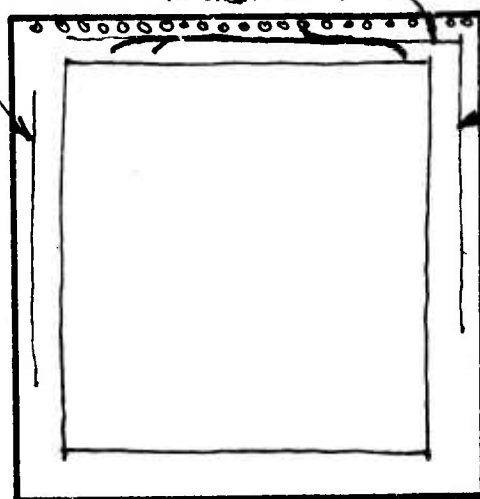
← SHEARED →

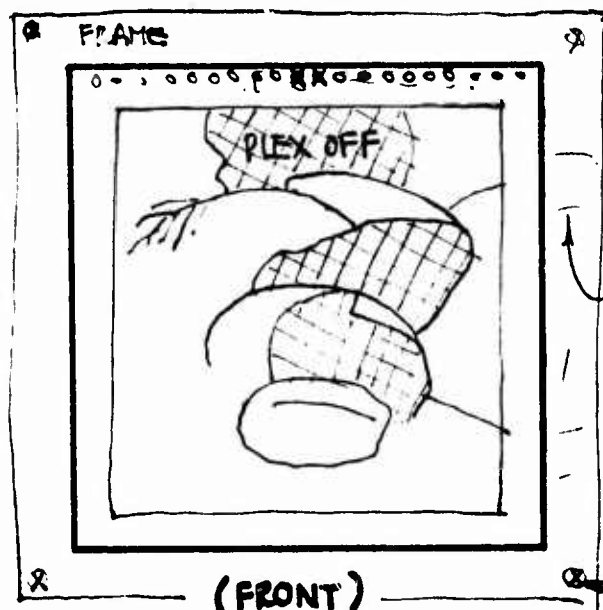
EDGE
HANDLING
SCRATCHES

FINE SCRATCHES ON 1/8 PC PRIOR TO TEST

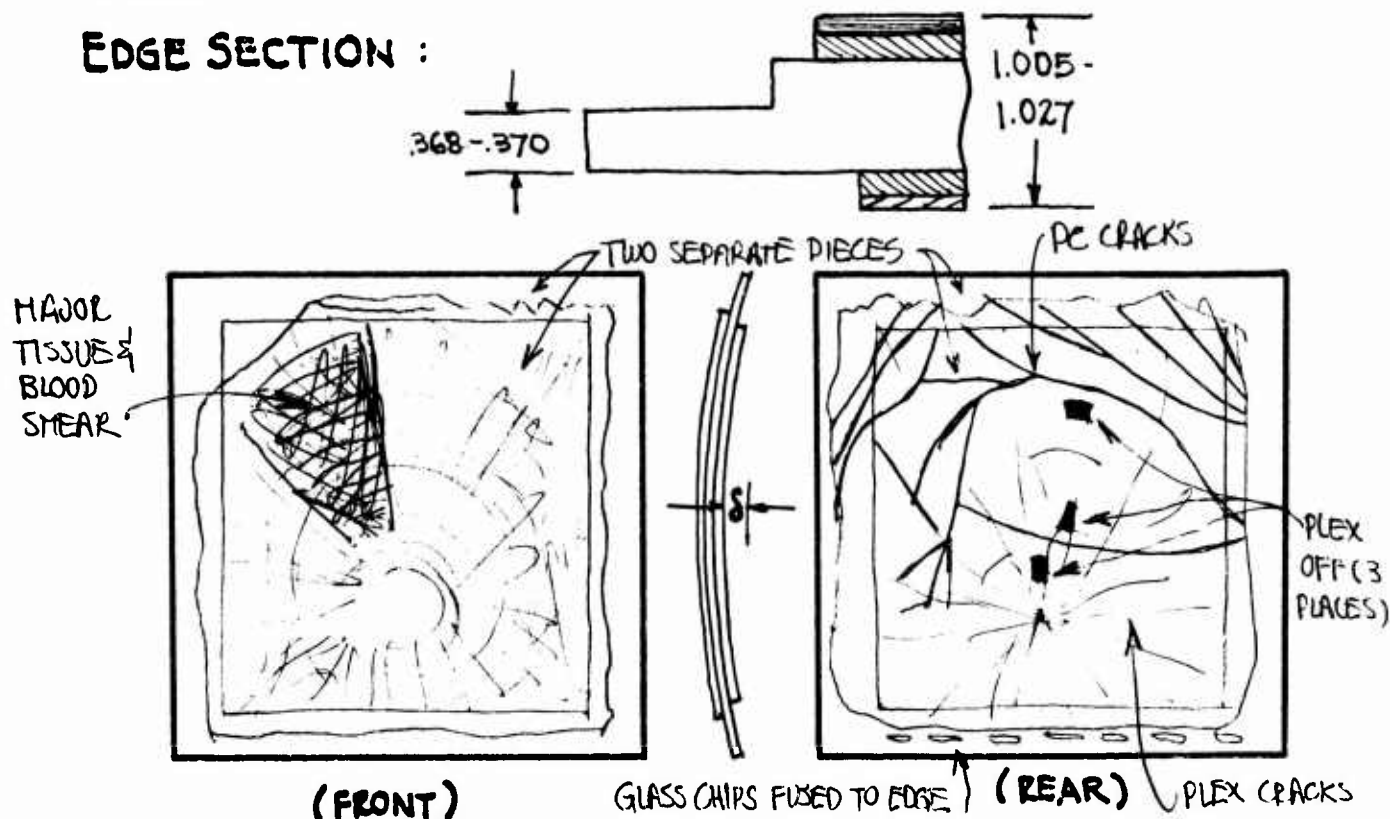
SHOT NO. : WT-8 SPEED : INTENDED : 850 FPS BIRD WT. : 4.18 LB.
FINAL : 858.8 "

BIRD PENETRATED. CENTER SECTION BLEW OUT LIKE 5A (SHOT WT-4). TOP EDGE SHEARING COINCIDES WITH BOTH OFFSETS BETWEEN EDGE AND FACING SECTIONS AND FRAME. MOST OTHER SHEARING COINCIDES WITH FRAME. PC CRACKED, 0% RESIDUAL VISIBILITY.

INBOARD ACRYLIC CRACKED WITH ORIGIN AT IMPACT PT., AND ALL CRACKS STOP AT 1/2 SURFACE. GOOD ADHESION THROUGHOUT ONLY 3 SMALL PIECES OF PLEX (~2 W²) WERE BLOWN OFF THE INBOARD SURFACE. VERY SLIGHT DELAM AROUND PC CRACKS.

BLOOD SHEAR & PC FRACTURE PATTERN INDICATES. MAY HAVE YAWED.

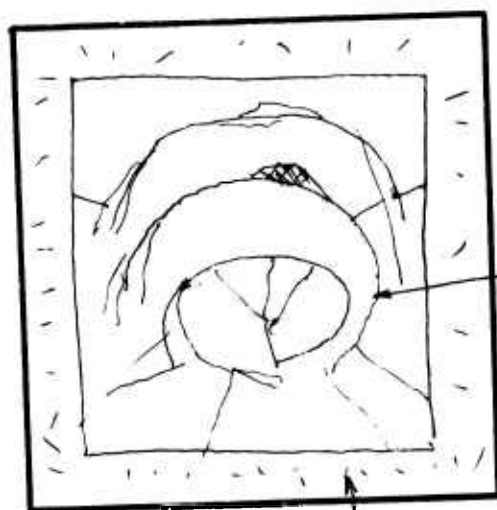
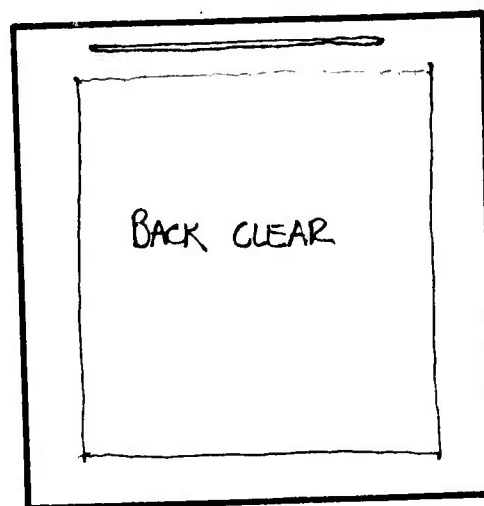
EDGE SCRATCHES FROM
HANDLING - NO EFFECT

BIRD DID NOT PENETRATE. NOT EVEN CLOSE, OUTBOARD FUSED
PLEX/PC PLY CRACKED BUT NOT REMOVED EXCEPT FOR 2-3 IN² AS
SHOWN. OUTBOARD PLY SHOWS CRACKS THRU ACRYLIC & PC BUT STOPPING
AT 1/2". GOOD RESIDUAL VISIBILITY (BEST OF 9 SO FAR). NO PC
CRACKING. NO SIGNIFICANT RESIDUAL PANEL DEFORMATION.

OVERALL CONDITION AS EXPECTED, BASED ON IN-HOUSE WORK.

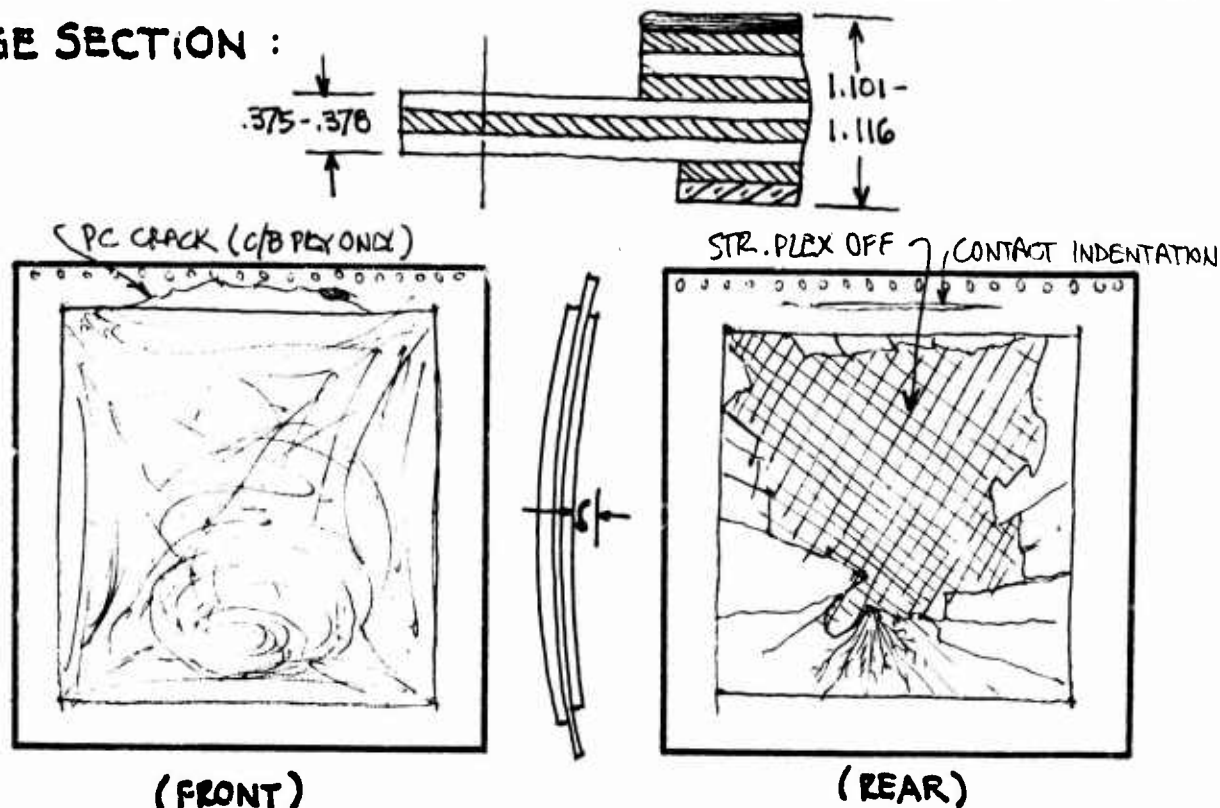
SHOT NO.: WT-10 SPEED: INTENDED: 850 FPS
TENTATIVE: 83.9" BIRD WT. : 4.0 LB
FINAL: 862.5" (511 KT) (46,185 FT-LB)
REMARKS : 1/2" SAMPLE SUBJECTED TO 3 AUTOCLAVE CYCLES.

BIRD DID NOT PENETRATE BUT STRETCHED ACRYLIC SPALL WAS EJECTED FROM THE INBOARD SURFACE, 80% OF S/A WAS REMOVED, PRIMARILY IN LONG SPLINES. SPALL PIECES SHOW TYPICAL RAZOR-EDGE LAMINAR FAILURE.

INBOARD PC SHOWS INDENTATION AND OUTBOARD PC (ACTUALLY MIDDLE PLY) CRACKED (10" LONG) WHERE BENT OVER FRAME. THERE WAS A SMALL DELAMINATION SPOT WHERE THE PC CRACK STOPPED AT THE 11/2 SURFACE. 0° RESIDUAL VISIBILITY.

SPALL SPEEDS (AEDC) : 269 FPS FOR 1.51" X .66" SPALL
191 FPS FOR 1.84" X 1.03" "

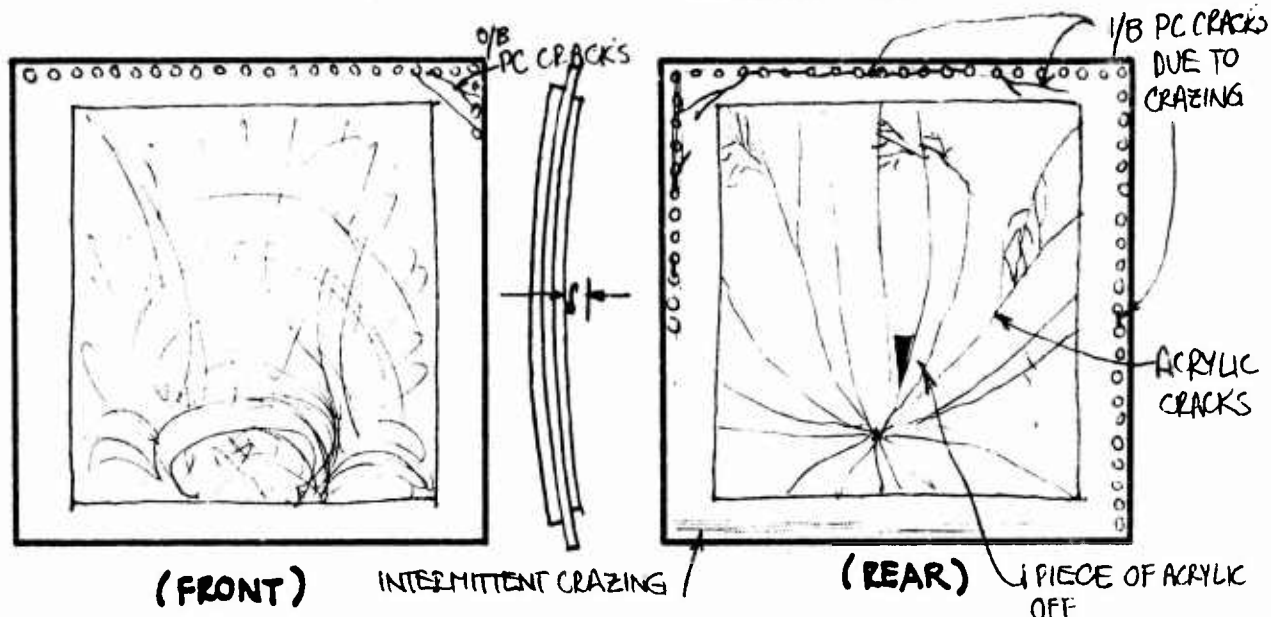
SHOT NO. : WT-II SPEED : INTENDED : 850 FPS
TENTATIVE : 874.6 " BIRD WT. : 4.12 LB
FINAL : 868.1 "

BIRD DID NOT PENETRATE. 0° RESIDUAL VISIBILITY. CORNER CRACK IN 2nd PC PLY (O/B IN EDGE). CRACKS BETWEEN BOLT HOLES ON TOP EDGE OVER FULL WIDTH OF 3rd PC PLY (1/8 IN EDGE) & SEVERAL CRACKS ALSO ON SIDES BETWEEN BOLT HOLES. INBOARD CRACKS DUE TO CRAZING WHICH RESULTED FROM IMPROPER EDGE SPACER DURING FABRICATION. THESE PROBABLY OCCURED ON REBOUND.

ACRYLIC CRACKED BUT 99% OF AS-CAST MATERIAL REMAINED ADHERED WITH ONLY ONE SMALL PIECE OFF NEAR IMPACT PT.

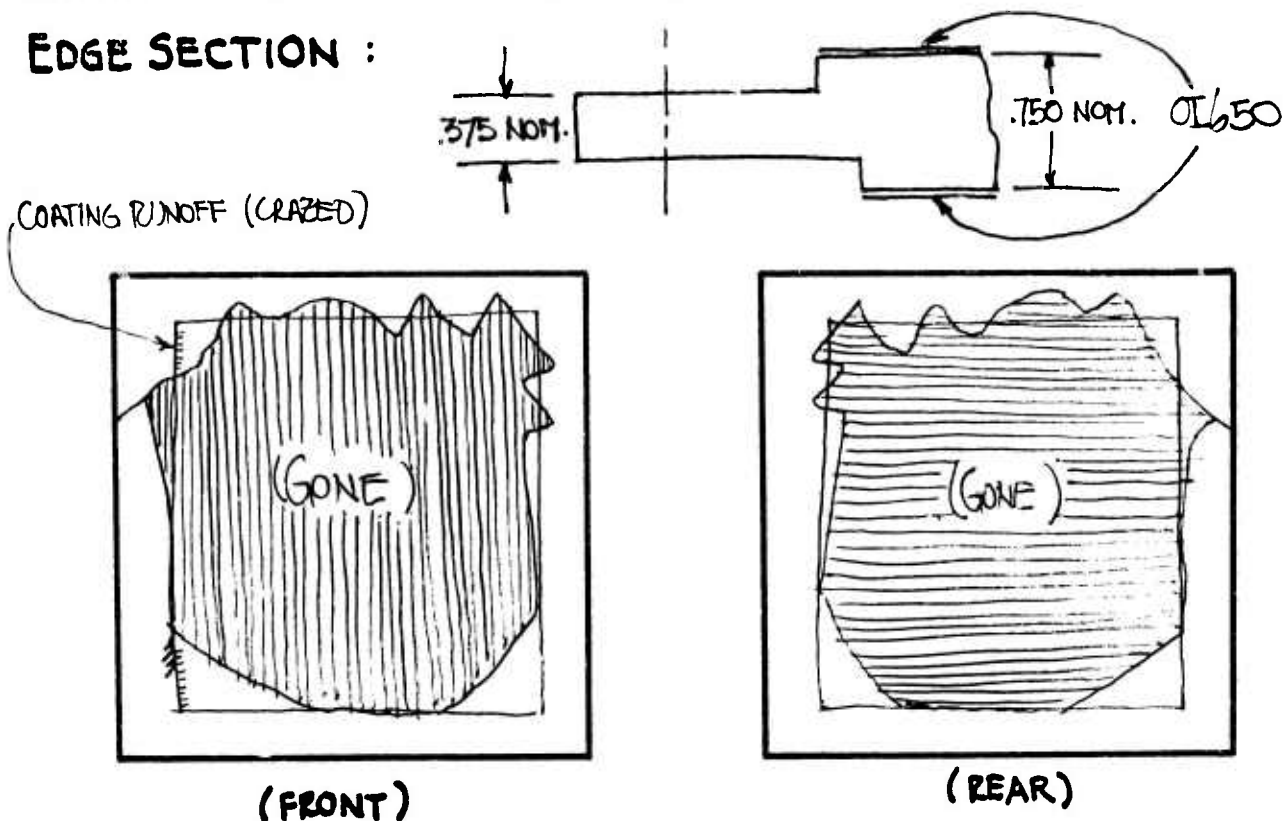
SHOT NO. : WT-12 SPEED : INTENDED : 800 FPS
TENTATIVE : 820.5 BIRD WT. : 4.15 LB.

BIRD PENETRATED. SAMPLE SHATTERED INTO NUMEROUS SMALL PIECES, MOST SMALLER THAN 6" x 6". FAILURE ON TOP EDGE EQUALLY DIVIDED BETWEEN IN LINE WITH FRAME AND IN LINE WITH CORNERS FORMED BY OUTBOARD AND INBOARD SECTIONS. MOST OTHER EDGE FAILURE CONNECTS DISCONTINUITY (CORNER) FORMED BY OUTBOARD AND INBOARD SECTIONS. PORTION REMAINING IN FRAME IN ONE PIECE - GOOD FUSION.

FAILURE REMINISCENT OF ACRYLIC-CLAD 3/4" PC WINDSHIELD TESTED 12-71.

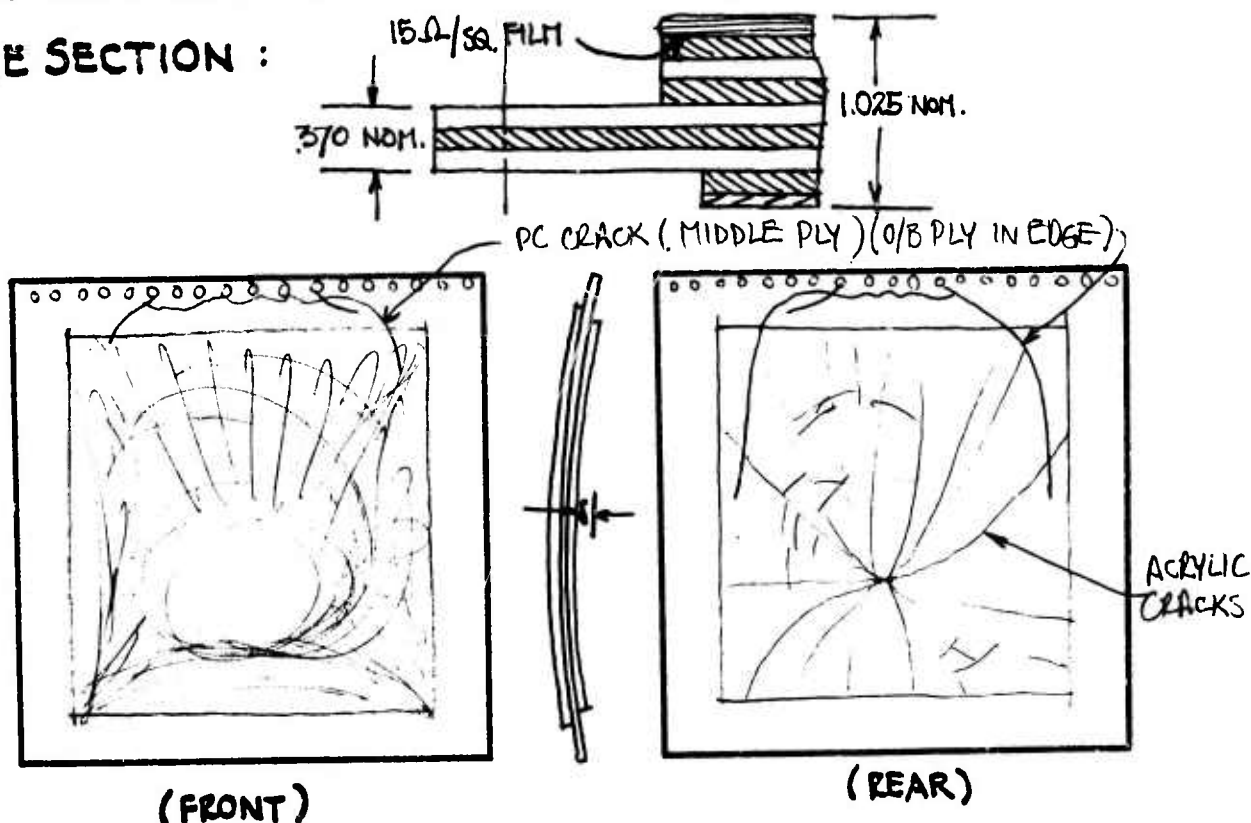
SHOT NO. : WT-13 SPEED : ^{INTENDED : 850 FPS} PRELIM. : 829.6 " BIRD WT. : 4.18 LB.
FINAL : 821.1 " (48 KT) (43,740 FT-LB)

BIRD DID NOT PENETRATE. ADHESION TO GOLD COATED GLASS COMPARABLE TO UNCOATED PANELS. CRACK IN MIDDLE PLY IN LINE WITH DEFORMATION OVER FRAME ALONG TOP EDGE. CRACK MAY CORROBORATE EMBRITTLEMENT INDICATED BY HARD DRILLING.

TYPICAL ACRYLIC CRACK PATTERN, NO OBSERVABLE ACRYLIC SPAULING. OVERALL PERFORMANCE SIMILAR TO 9A (SHOT WT-11).

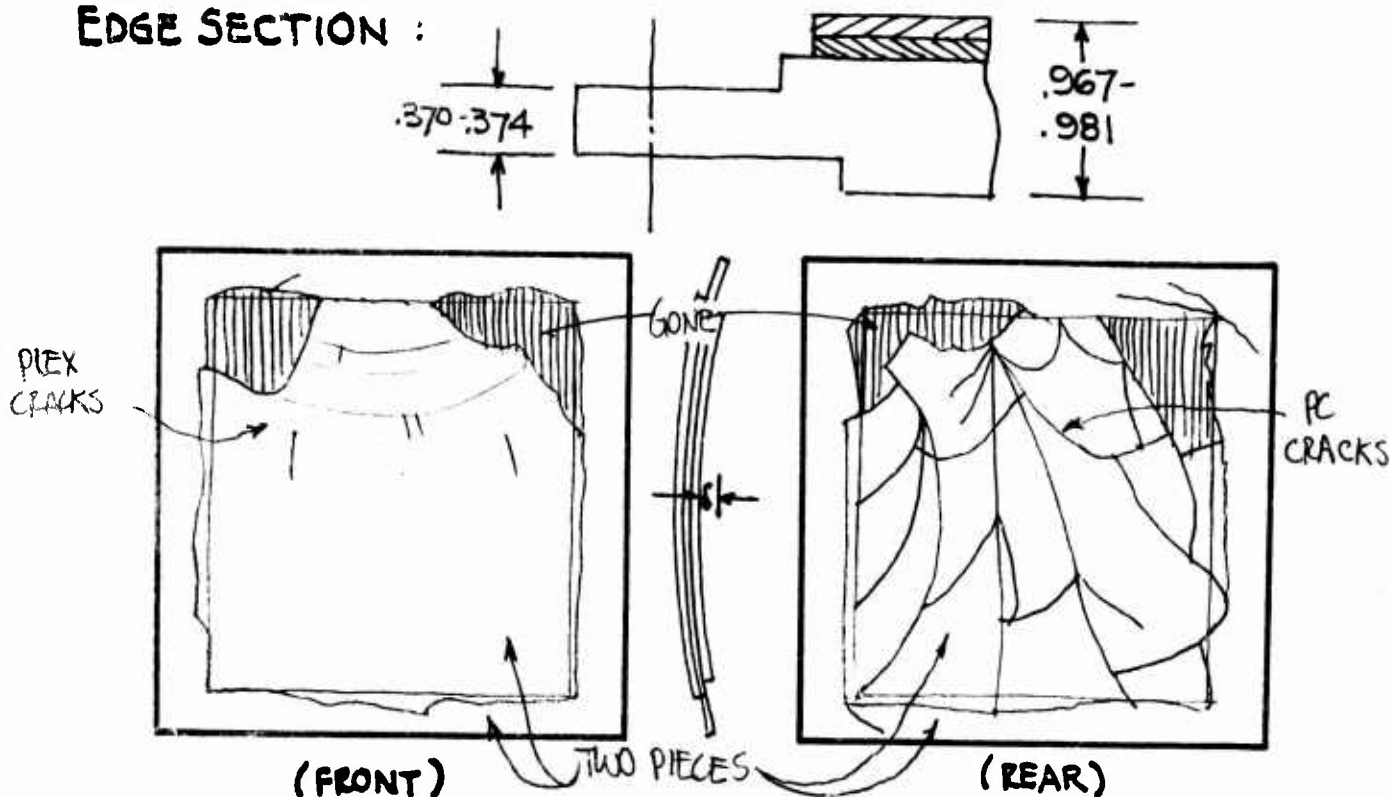
SHOT NO. : WT-14 SPEED : INTENDED : 850 FPS
PRELIM : 862.8" BIRD WT. : 3.91 LB.
ACTUAL : 847.7"

BIRD PENETRATED. ENTIRE CENTER OF PANEL BLEW OUT. TOP CENTER SHEARING IN LINE WITH OFFSET INBOARD AND OUTBOARD SECTIONS. THICK PC PLY SEVERELY SHATTERED. GOOD FUSION. PC AND ACRYLIC CRACKS ORIGINATE AT TOP EDGE WITH NO DAMAGE AT IMPACT POINT - UNUSUAL. PROBABLY DUE TO RIGIDITY OF 3/4" PC PLY.

NO OBSERVABLE CRACK PROPAGATION THRU .090" 1/2 IN REMAINING PORTION

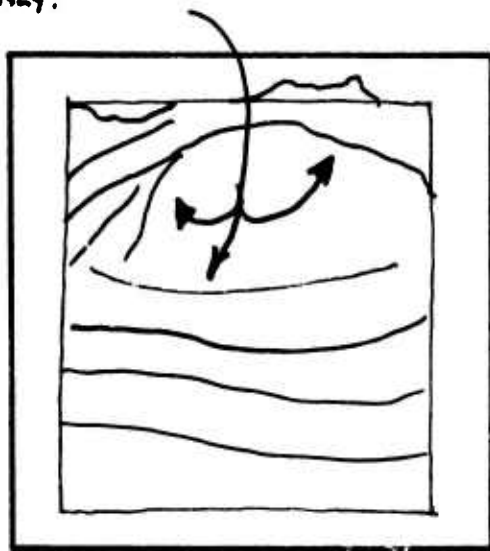
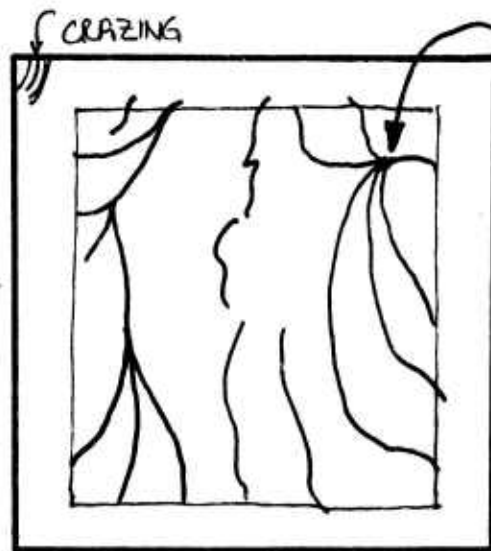
LIGHT CRACKING IN FRONT
PLY ONLY.

BIRD PENETRATED. ENTIRE CENTER SECTION BLOWN OUT.
SHEARING ON TOP EDGE APPROX. 75 % COINCIDENT WITH BACK
FUSED SECTION. FUSION VERY GOOD. NO APPARENT DE-LAM.
CRACKING ON BACK SIDE SEVERE BUT NO PIECES BLOWN LOOSE.

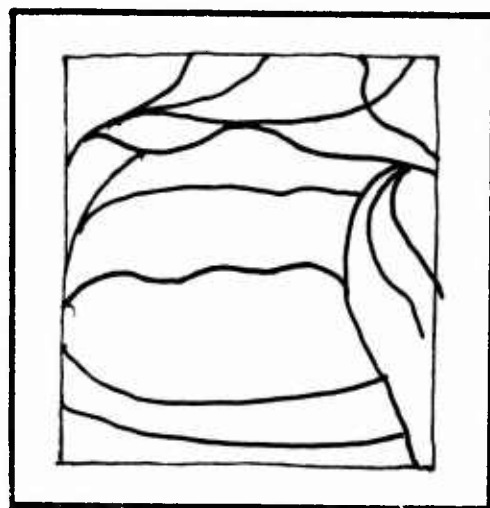
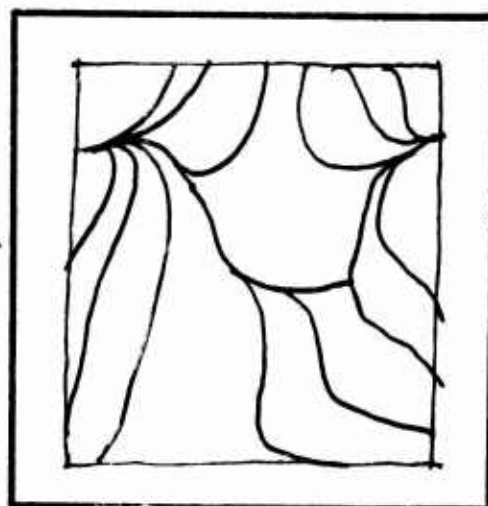
BIRD PENETRATED. ENTIRE CENTER SECTION BLOWN OUT.
TOP EDGE SHEARED OUT COINCIDENT WITH BACK FUSED PLY.
GOOD FUSION. NO PIECES BLOWN LOOSE FROM FUSED FACES.

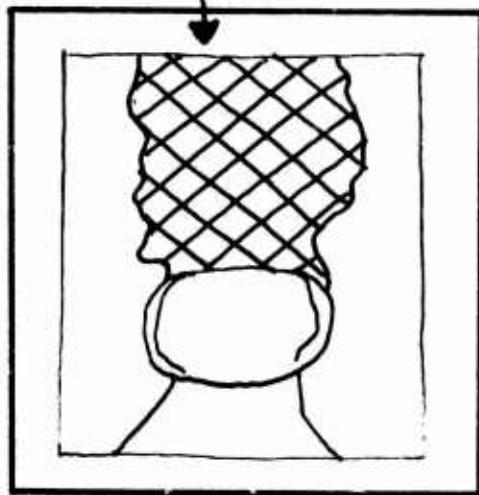
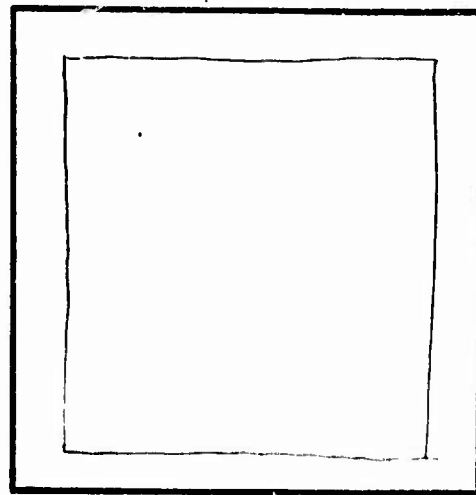
BIRD BOUNCED. NO POLYCARBONATE CRACKING ON BACK
PLY. NO SHEARING OR CRACKING ON TOP EDGE. BEST
PERFORMANCE OF ALL PANELS SHOT ??? APPROX. 30% OF
OUTBOARD PLY BLOWN OFF. GOOD ADHESION ELSEWHERE.
RESIDUAL VISIBILITY EXCELLENT.

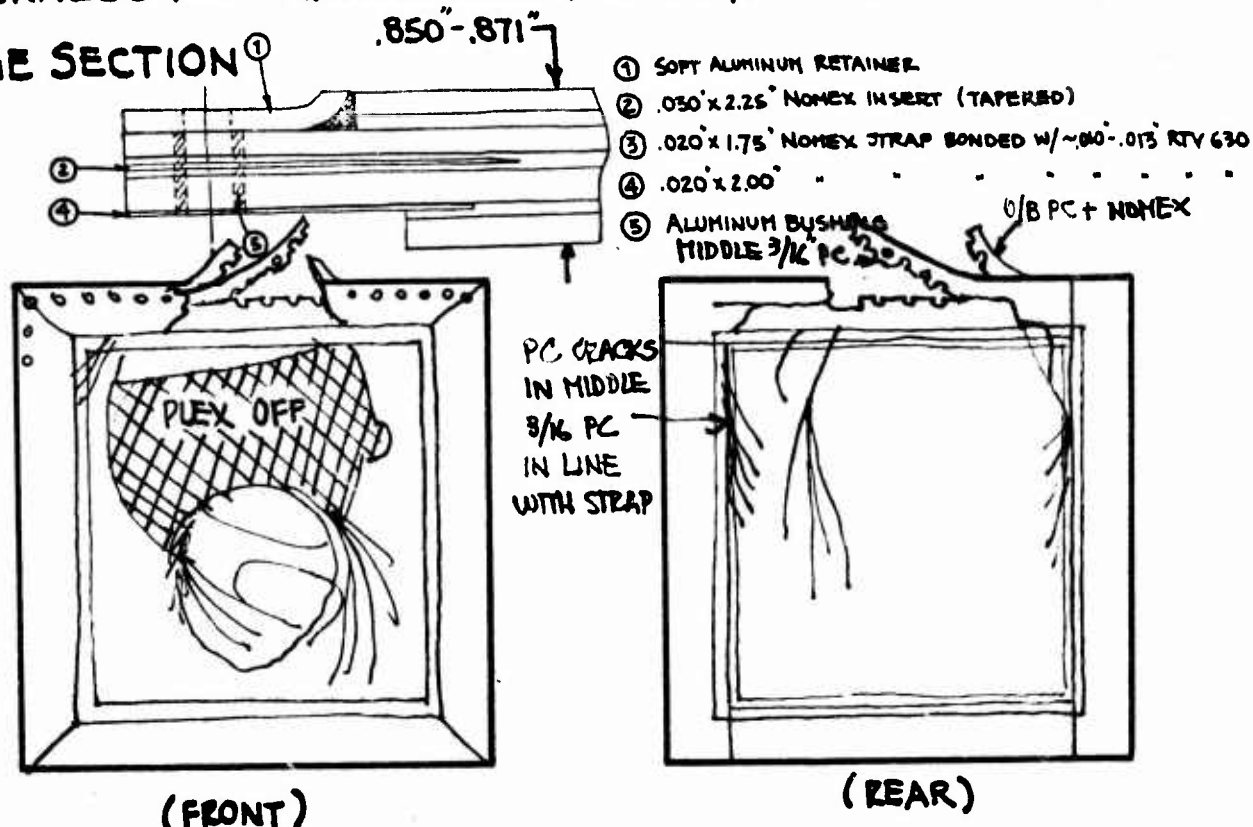
SHOT NO. : WT-19 SPEED : INTENDED : 850 FPS
(1) PRELIM. : 901 " BIRD WT. : 4.11 LB
FINAL : 901 " K.E. : 51,693 FT-LBS
" 533 KT.

BIRD PENETRATED. TOP EDGE SHEARED 18". RETAINER PEELED BACK & REMOVED OVER 8" ON TOP EDGE. 1/8" PC PLY SHEARED IN LINE WITH BOLT HOLES AROUND PENETRATION. COHESIVE FAILURE OF INSERT IN PENETRATION AREA. 3/16" PC PLY FAILED GENERALLY IN LINE WITH FRAME AT TOP. FLOATING PC OK. SIDE PC CRACKS IN LINE WITH STRAPS, NOT INSERT OR FLOATING PLY.

NO CRACKS VISIBLE THRU .090" & .060" INTERLAYERS.

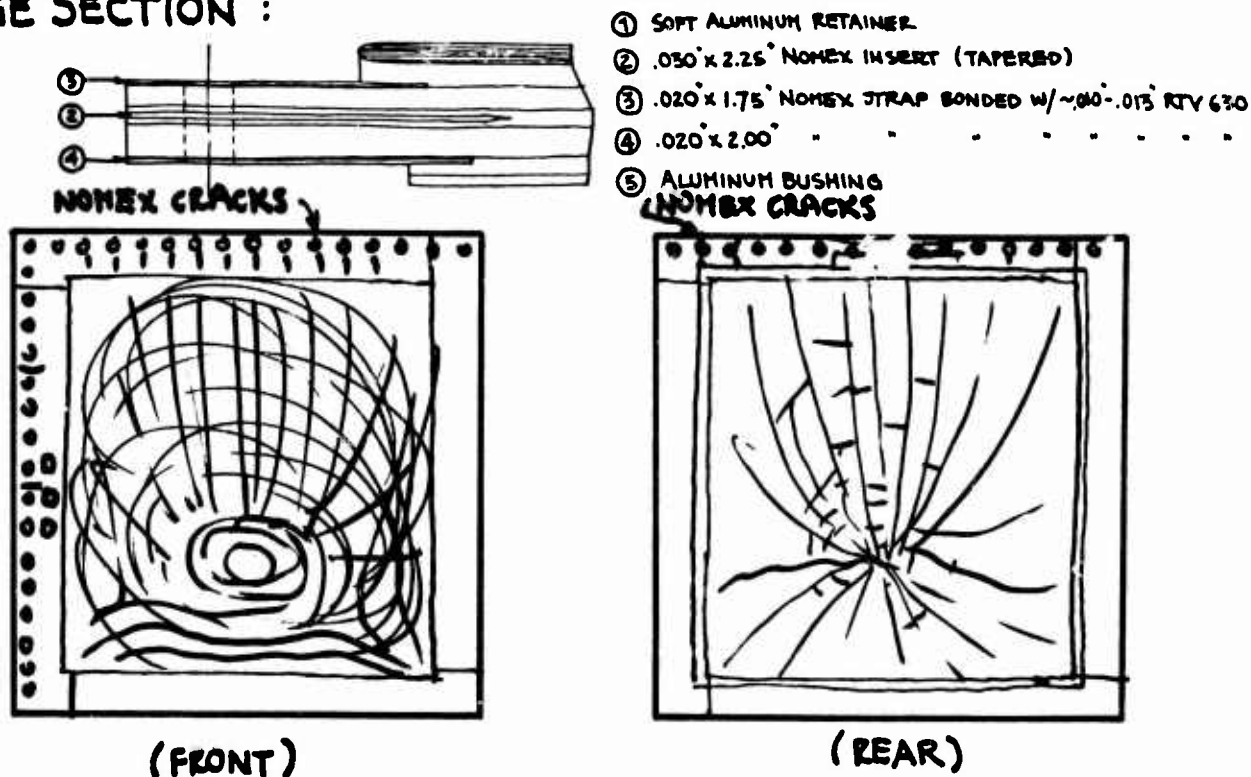
SHOT NO.: WT-20 SPEED: INTENDED 850 FPS BIRD WT. : 1826 Gms (4.12 #)
(No.2) PRELIM 870 FPS
REMARKS : FINAL 870 " K.E. : 47,226 FT-LBS
" 515 KT

ONE OR TWO OF TISSUE THRU BOLT HOLES AND AFTER BOLT FAILURE WHICH ALLOWED EDGE TO DEFLECT DOWNWARD. SIXTEEN BOLTS GONE FROM TOP EDGE. CENTRAL $7\frac{1}{2}$ " OF $3/16$ " PC PERMANENTLY DEFORMED INWARD, ONLY TWO BOLT HOLES AT END OF DEFORMATION CRACKED ALL OTHERS OK. $1/8$ " PC INTACT BUT DEFORMED IN CENTER OF TOP EDGE. NO PC CRACKS. PLEX CRACKED BUT NO SPALL AT ALL.

SOME TENSILE CRACKS IN TOP EDGE NOMEX BUT NONE INTO PC.

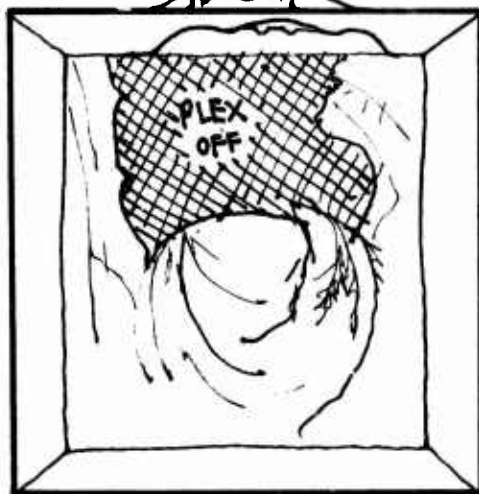
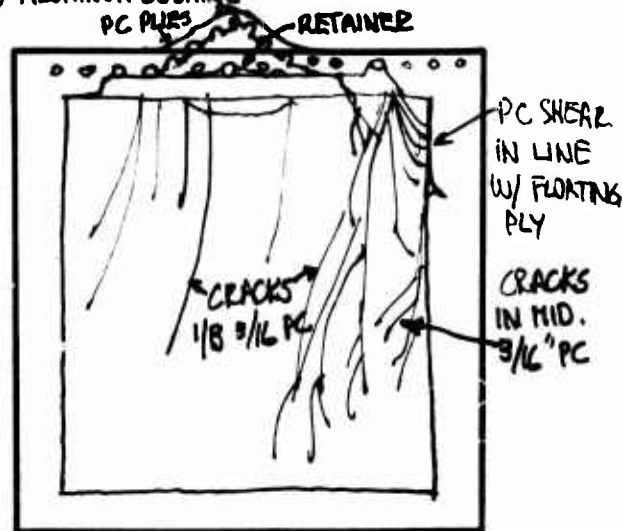
BIRD PENETRATED. AS WITH 17A (WT-19), CENTRAL 18" PORTION OF TOP EDGE SHEARED. IN THIS CASE, THE RETAINER WAS NOT REMOVED BUT ONLY PEELED BACK IN THE IMPACT AREA. AS SUCH IT ACTED LIKE A FUNNEL DIVERTING THE HYDROSTATIC PRESSURE DOWN INTO THE EDGE AND PARALLEL TO THE FRAME, PUSHING THE SHEARED $\frac{1}{8}$ " & $\frac{3}{16}$ " PC EDGE PILES OUT ALONG THE FRAME.

CRACKS IN ALL 3 PLYS OF ~~100~~ PC BUT NO PROPAGATION THROUGH 1/2
LITTLE OBSERVABLE DIFFERENCE BETWEEN EFFECT OF EDGE
REINFORCEMENT HERE AND IN M-A.

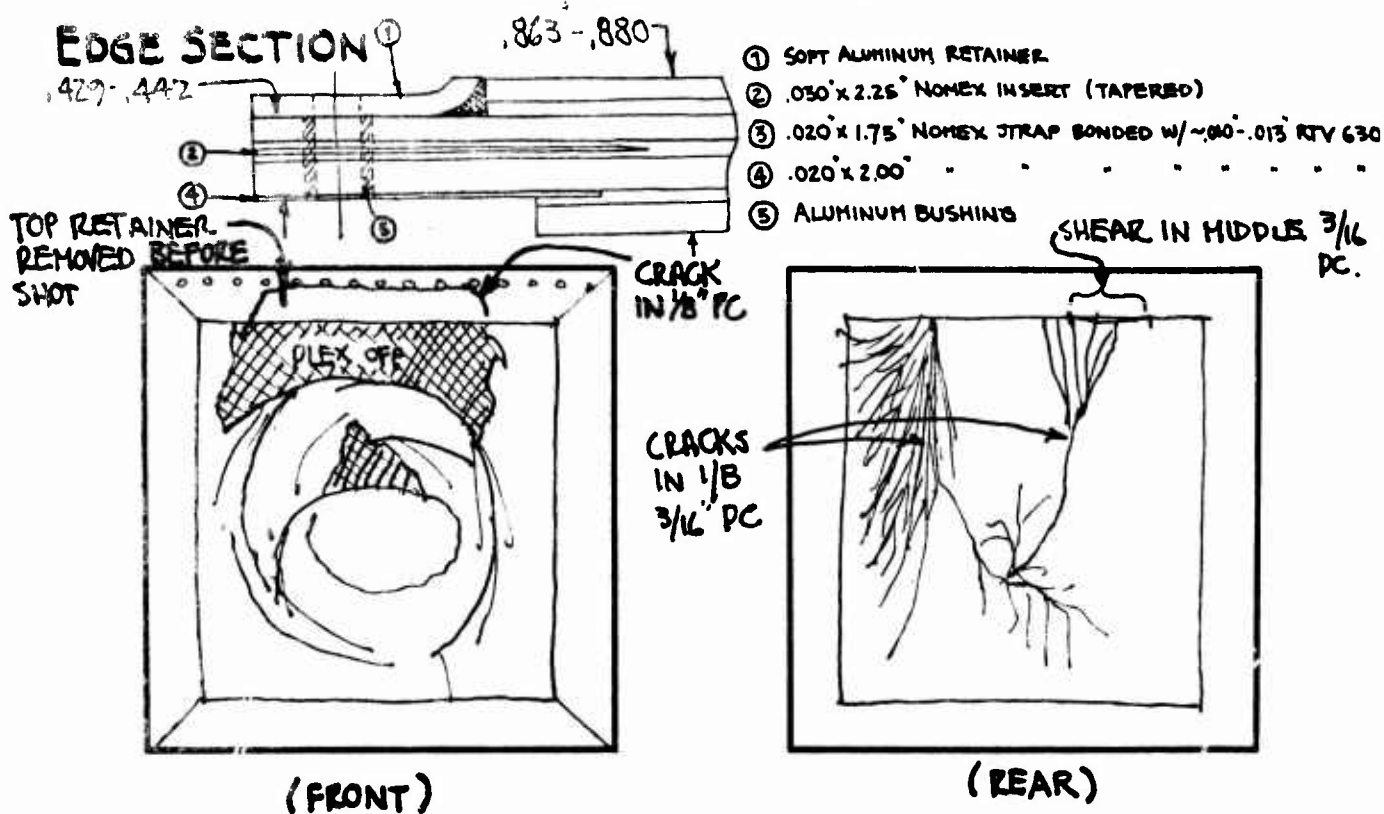
SHOT NO.: WT-22 SPEED: INTENDED : 850 FPS
(NO.4) PRELIM : 901 FPS BIRD WT. : 1815 gm (4.0 LB)
FINAL : 881 FPS K.E. : 48,042 FT-LBS
" : 521 KT

BIRD TISSUE THRU BOLT HOLES AND 4" SHEAR IN MID 3/16" PC PLY.
NINE OF 21 BOLTS GONE ON TOP EDGE. WITHOUT RETAINER NO SHEARING OF EDGE PLIES, BUT, WITH BOLTS GONE, MIDDLE PC PLY WAS BENT SEVERLY OVER FRAME WITH 4" CRACK IN LINE WITH FLOATING PLY. INSERT GENERALLY HELD. FLOATING PLY CRACKED AS SHOWN.

BOLTS FAILING AT 1ST OR 2ND THREAD IN LINE WITH BOTTOM OF PANEL. IT IS APPARENT THAT THIS SHOT AND WT-20 WERE TESTING BOLTS MORE THAN PANELS ALONE.

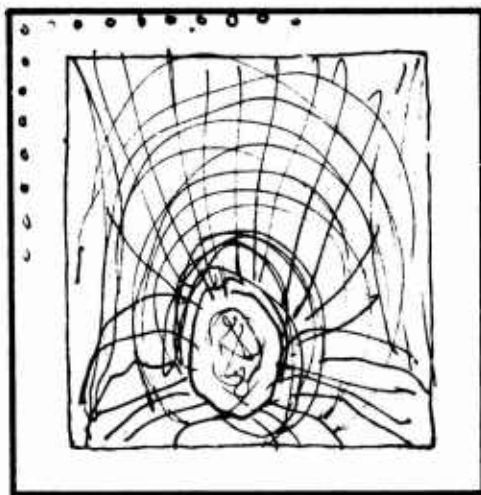
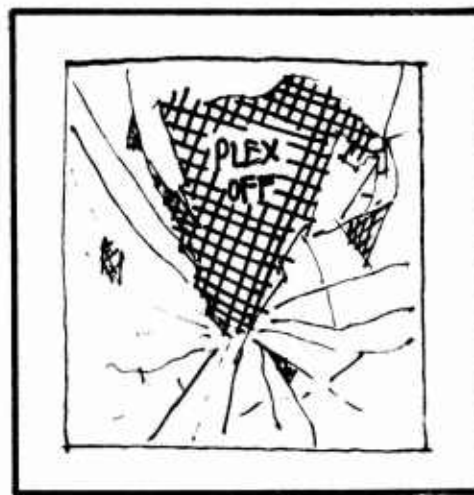
BIRD DID NOT PENETRATE. NO SERIOUS DAMAGE TO PANEL. NO PC CRACKS. SIX BOLTS REMOVED ALONG TOP EDGE BUT NO TISSUE THRU HOLES. BOLTS FAILED, AS BEFORE, AT SHANK-THREAD TRANSITION. 50% OF ACRYLIC OFF INBOARD AS SPALL. POSSIBLE THAT ACRYLIC PREPARATION NOT COMPLETE (NO CEMENT)

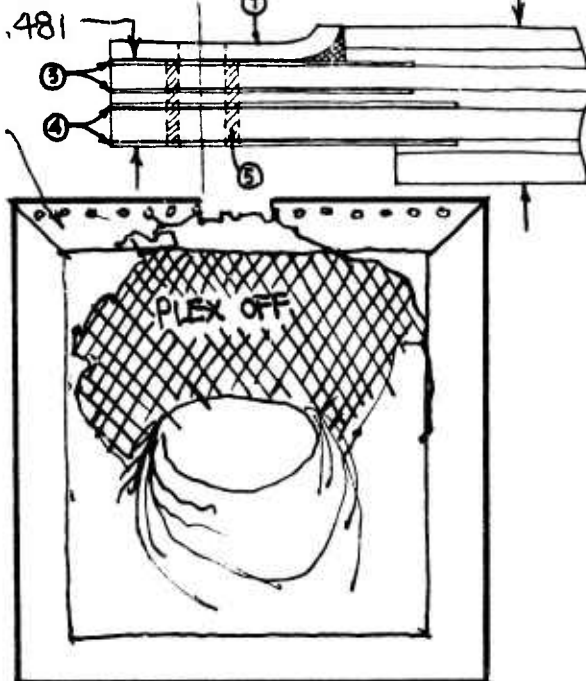
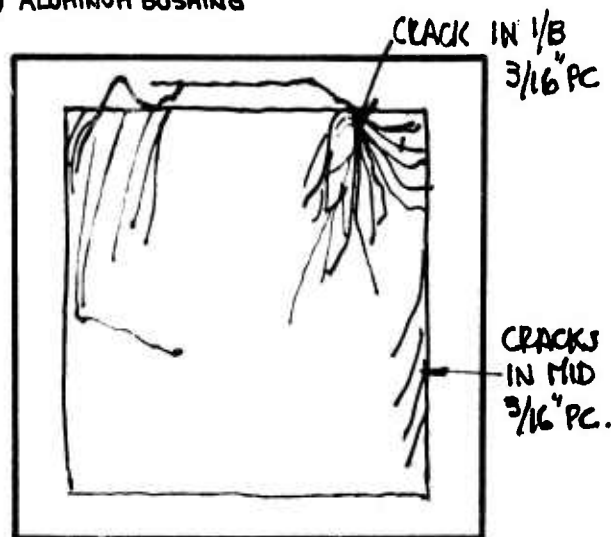
SHOT NO.: WT-24 SPEED
NO. 6

ETAINER
REMOVED
BEFORE
SHOT

BIRD PENETRATED. ENTIRE TOP EDGE SHEARED. CENTRAL IMPACT PORTION OF TOP EDGE AND PORTIONS OF TOP HALF OF SIDES SHEARED IN LINE WITH FRAME. FAILURE WORSE THAN 18A (WT-21) WHICH HAD A RETAINER ON TOP EDGE.

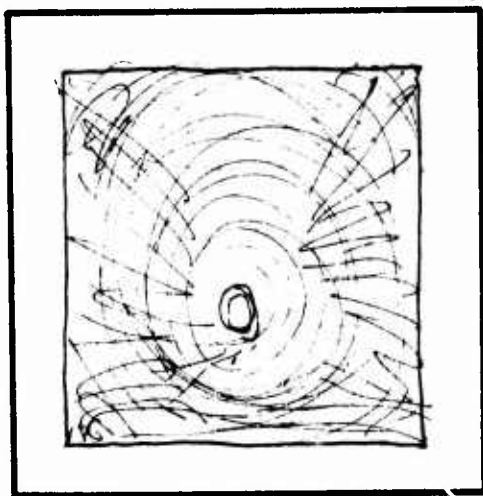
IMPRESSION
FROM
BENDING
OVER
FRAME

SLIGHT
NECKING
OF IIZ &
DELAM.
AT PLEX
CRACKS
IN MAX.
BULGE

BIRD DID NOT PENETRATE. NO EDGE DAMAGE EXCEPT CRACKS IN OUTBOARD NOMEX DUE TO MAX STRESS FROM BENDING OVER FRAME. 3" INTERLAMINAR SEPARATION OF O/B-FACING STRAP ON 1/B PC PLY VISIBLE AT CENTER OF TOP EDGE.

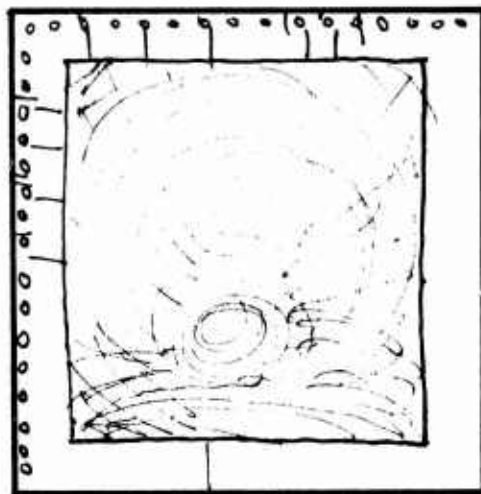
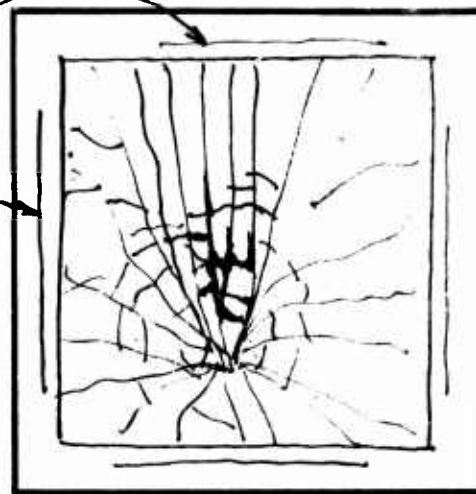
IMPRESSION
FROM
BENDING
OVER
FRAME

BIRD DID NOT PENETRATE. SIX BOLTS OFF TOP EDGE. NO DAMAGE TO EDGE ANYWHERE EXCEPT NOMEX CRACKS AT BOLT HOLES AS SHOWN. NO PC CRACKS OR DAMAGE.

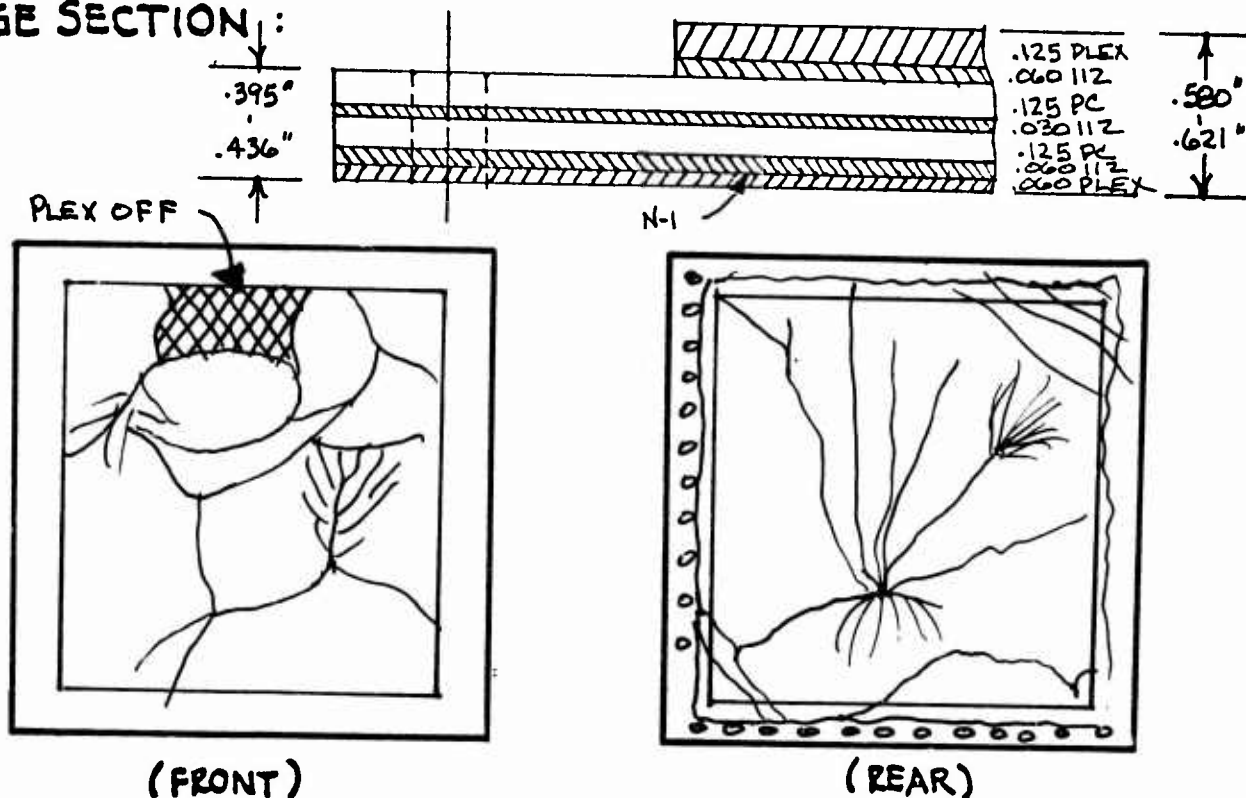
BIRD DID NOT PENETRATE. NO SERIOUS STRUCTURAL DAMAGE. BOTH ACRYLIC RACING BLIES FAILED HOWEVER NO SPALL WHATSOEVER FROM INBOARD PLY. I/B ACRYLIC CRACKED WHERE BEINT OVER FRAME. THIN I/B ACRYLIC PLY SHOULD BE FLOATING W/ STRAP OR SPACER PREVENTING INTERIOR ENCROACHMENT SINCE SOME CRACKS FORMED DURING MOUNTING.
